# BATH SOUTHGATE RAILWAY STATION AVONSIDE HOUSE DESIGN AND ACCESS REPORT

LISTED BUILDING CONSENT APPLICATION

19.12.2008

# **DESIGN STATEMENT**

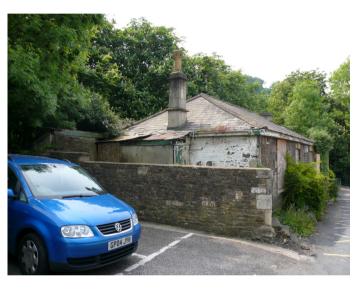
Car park spaces are parallel to east elevation which obstructs an entrance from this direction, The existing stone wall provides the boundary to the car park. Latter addition of the lean-to extension located to the east elevation is to be removed.

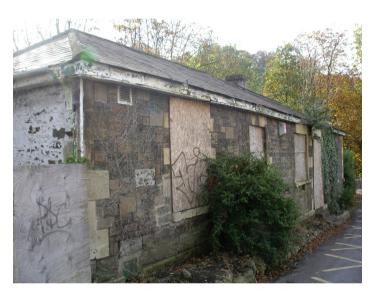
North elevation with boarded up windows and external door. Existing road is directly parallel to the elevation with no designated pedestrian circulation in front of the building. External walls and windows require repair and Roof edge and guttering require restoration.

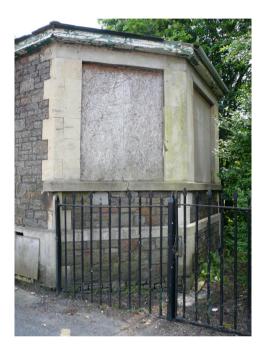
West elevation with bay window and spearhead railings. Railings to be reused in proposed landscape scheme. As with the north elevation the external walls and windows require repair and roof edge and guttering require restoration.

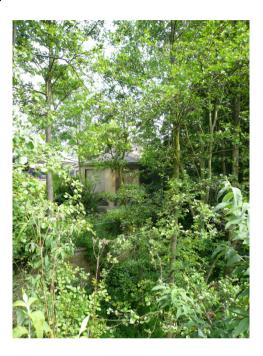
View of west elevation from Ha'penny Bridge showing broken existing scaffold railing to south retaining wall.

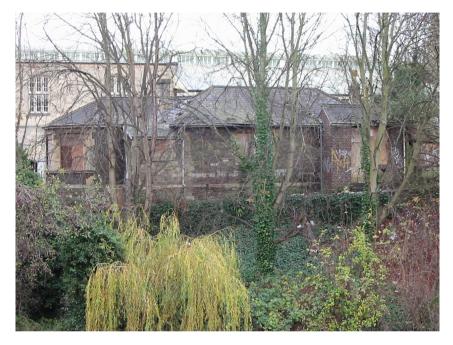
South Elevation also showing south retaining wall that will require significant repair to provide structural stability. It is thought that the sloping nature of the site is causing the structural problems that are particular to the south side. Existing trees and under growth will require pruning to stabilize foundations

Landscape: Stabilise south retaining wall with removal of Ivy growth and undergrowth of saplings and re-pointing as required

Prune existing mature trees and clear extensive undergrowth as required to stabilize existing foundations and stone walls

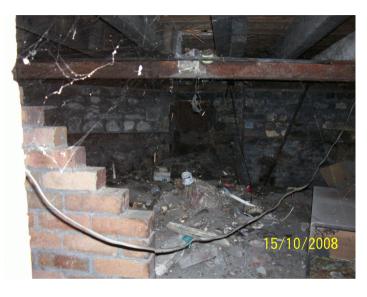
Basement below west end of the building extends below the footprint of the building raising up to the north and east

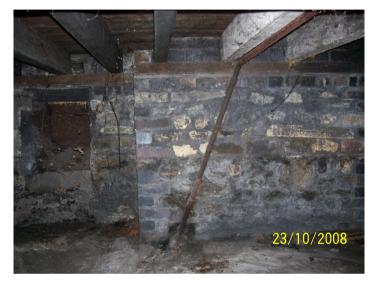
Basement area with existing ventilation provided on the south elevation.
